NCSC-TM-298-80

4. TITLE (and Subtitle) (6) Test Results of Heat Exchanger Cleaning in Support of Ocean Thermal Energy Conversion	5. TYPE OF REPORT & PERIOD COVERED September 1978-May 1980

7. AUTHOR(s) (10) Daniel F. Lott	6. PERFORMING ORG. REPORT NUMBER	
9. PERFORMING ORGANIZATION NAME AND ADDRESS Naval Coastal Systems Center Panama City, FL 32407	8. CONTRACT OR GRANT NUMBER(s)

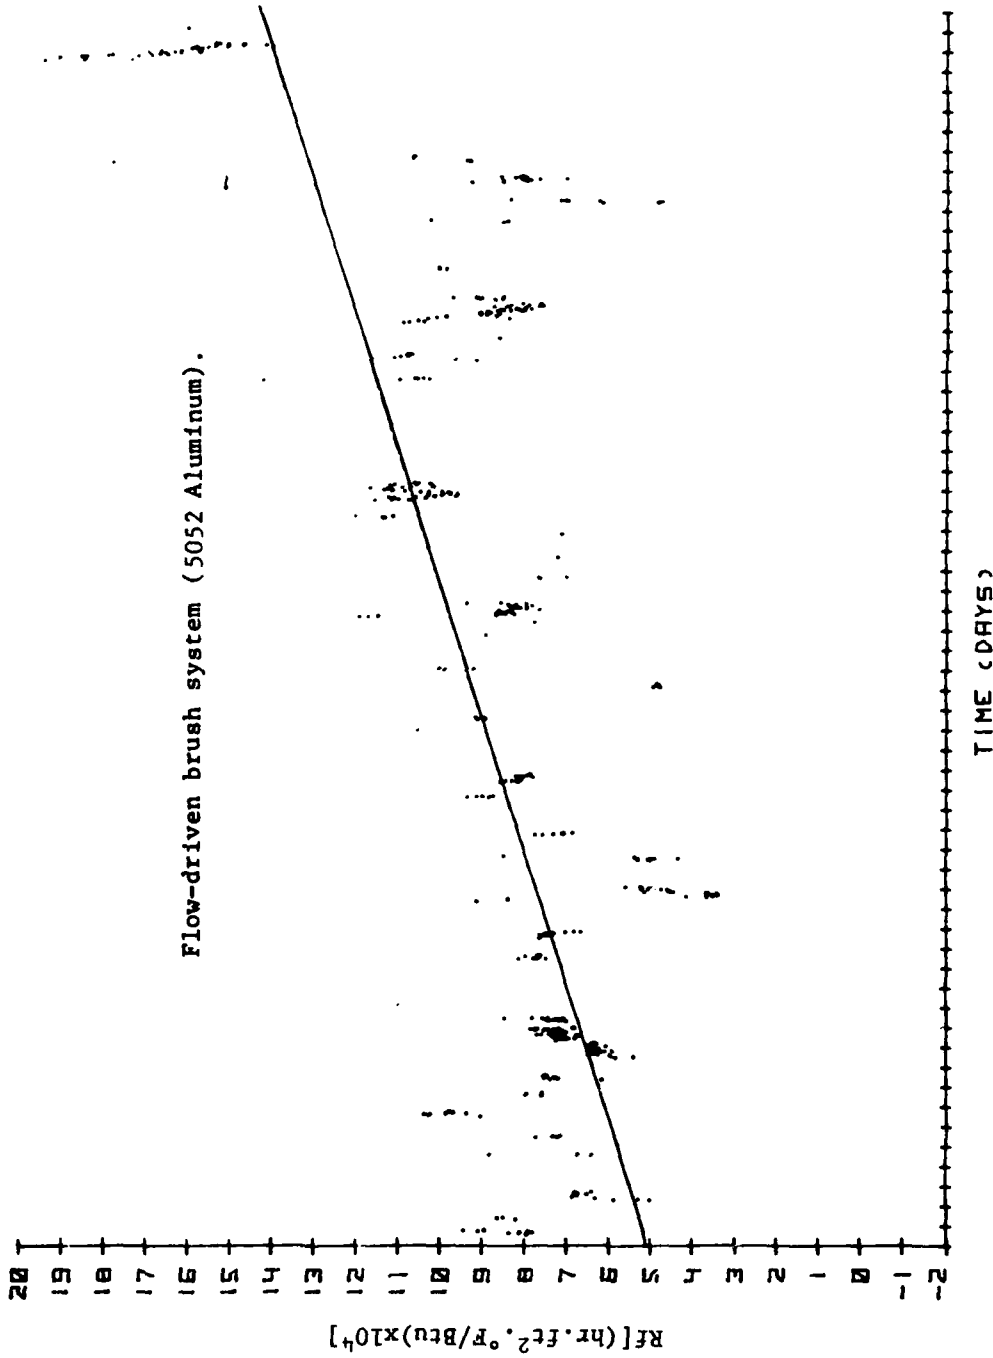
FIGURE 20. THERMAL RESISTANCE (Rf) VS TIME FOR TUBE 5 (ALUMINUM)

Although the flow-driven brush system performed well in this evaluation, there was evidence of brush fatigue even at the end of this relatively short test period. Measurements of bristle length before and after the test showed an average decrease of 0.014 inch (0.34 mm) in bristle length. Microscopic examination revealed a distinct flattening of the bristle ends due to wear. Thus, bristle wear rate will become a significant design factor in the effectiveness of this brushing system.

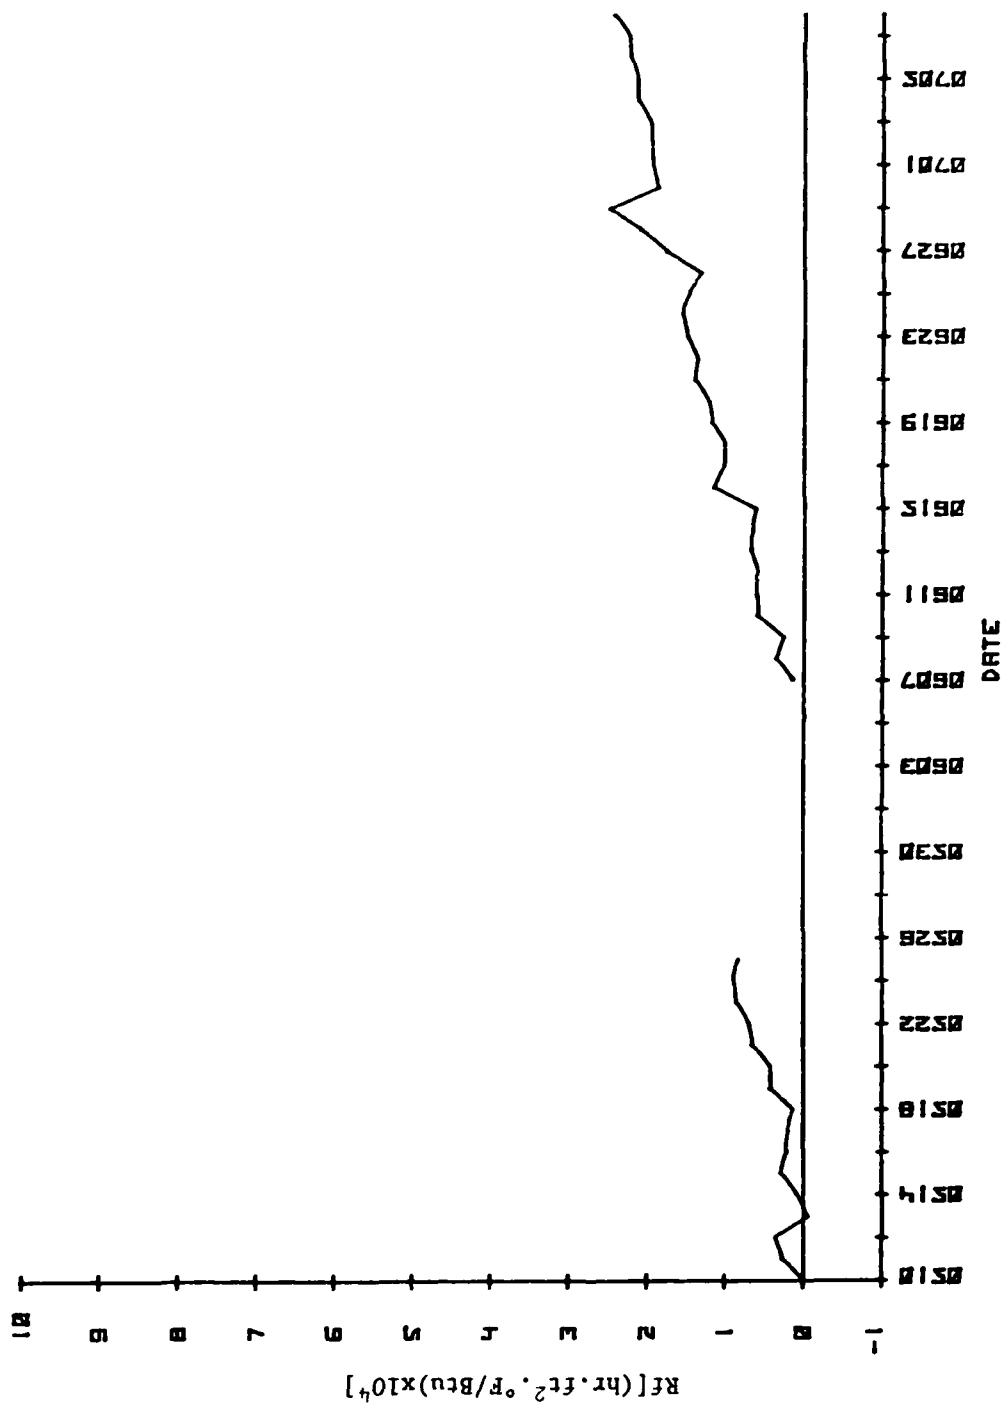
FIGURE 27. FOULING RESISTANCE DATA IN THE ALUMINUM RECIRCULATING SPONGE-RUBBER BALL CLEANING SYSTEM

Performance of the 28 mm "hard" ball is shown in Figure 27 for aluminum and Figure 28 for titanium pipe. For the period 10 to 24 May, ball recirculation was by peristaltic pumps. With this system, the aluminum pipe showed a gradual increase in  $R_f$  to  $2.0 \times 10^{-4} \text{ ft}^2\text{-hr-}^\circ\text{F/Btu}$  in 2 weeks. Results in the titanium tube were not so clear. Oscillations in the curve represent problems with ball movement that occurred in this test system. Peristaltic pumps were inadequate for evaluation of ball cleaning effectiveness. During the 14-day period, there were five major problems preventing ball movement and affecting cleaning performance. Tests were finally terminated when the pump motor burned out (24 May).

On 7 June, a test with the 28 mm "hard" ball operating on a 15-minute cycle was initiated using the ANL designed system. Results are seen in Figure 27 (Alloy 5052) and Figure 28 (Ti). Although subject to perturbations, the aluminum pipe showed a gradual increasing trend in  $R_f$  throughout the 34-day test period. At the end of 34 days,  $R_f$  approached  $2.5 \times 10^{-4} \text{ ft}^2\text{-hr-}^\circ\text{F/Btu}$ .

Two major problems occurred with the ANL test system which affected system performance and resulted in oscillations in  $R_f$  plots for each pipe material. The first of these involved the destruction of test balls during ball release. As soon as rotation from the catch to release position commenced, a suction holding the ball in the catcher was released. The loose ball would become trapped between the ball catcher and the catcher housing. This destroyed the ball and jammed the catcher. This problem was eliminated by installing a pedestal in the catcher that compressed the ball, holding it in the catcher when suction was released. No further problems with ball destruction occurred.

The second and major problem encountered was a tendency for the catcher to "hang open" in the release position. This resulted from an inadequate pressure differential between the seawater header and HTM. Several modifications were attempted but none prevented reoccurrences of the problem. Use of this system was discontinued in later tests.

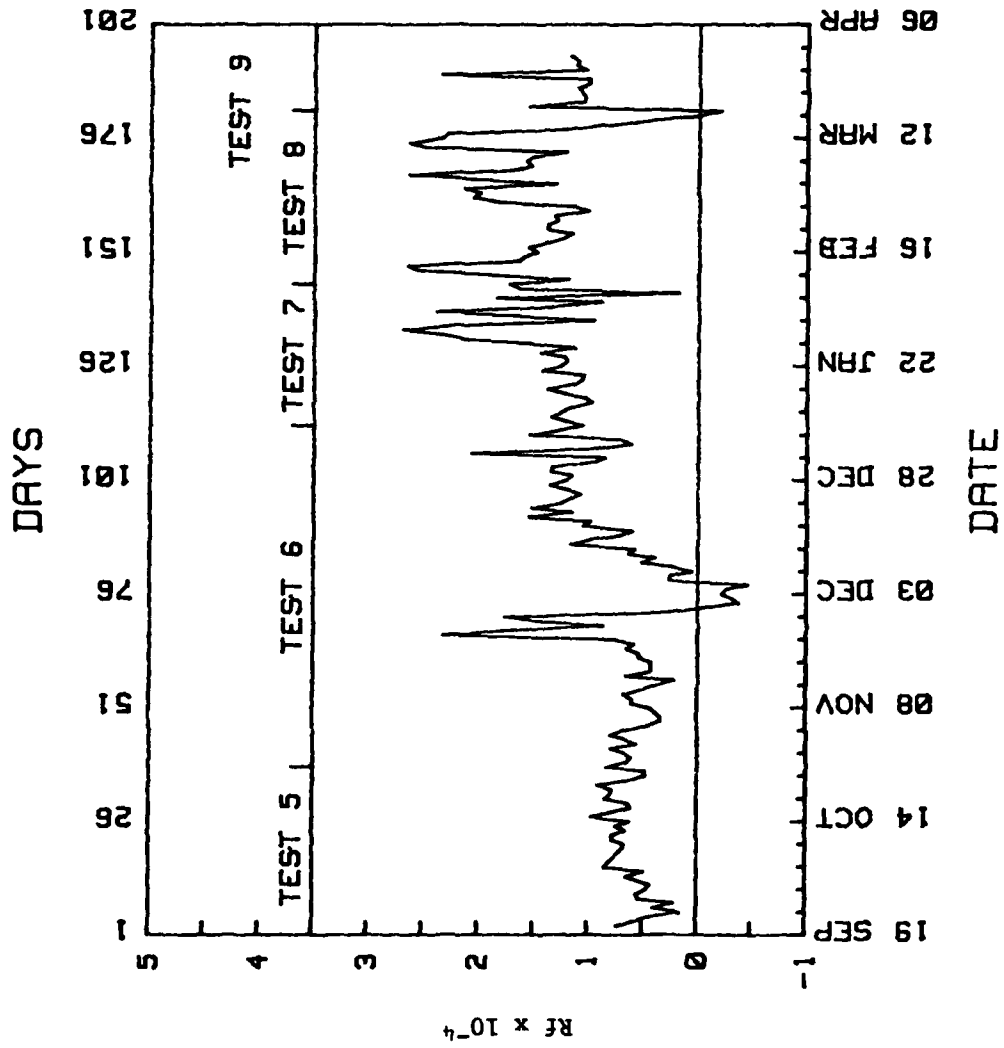
FIGURE 34. FOULING RESISTANCE VERSUS DATE, FLOW-DRIVEN BRUSH IN TITANIUM PIPE

It was evident that, for conditions tested, target levels of Rf could be achieved in titanium pipe using the 28-mm brush operating on a 4, 6, or 8-hour cycle. Further study is required, however, concerning the response of titanium to (1) cleaning effectiveness and (2) seasonal rates of fouling. It should be
